East Fairview Drainage Study

Town of Fairview

Huitt-Zollars, Inc.

October 08, 2020

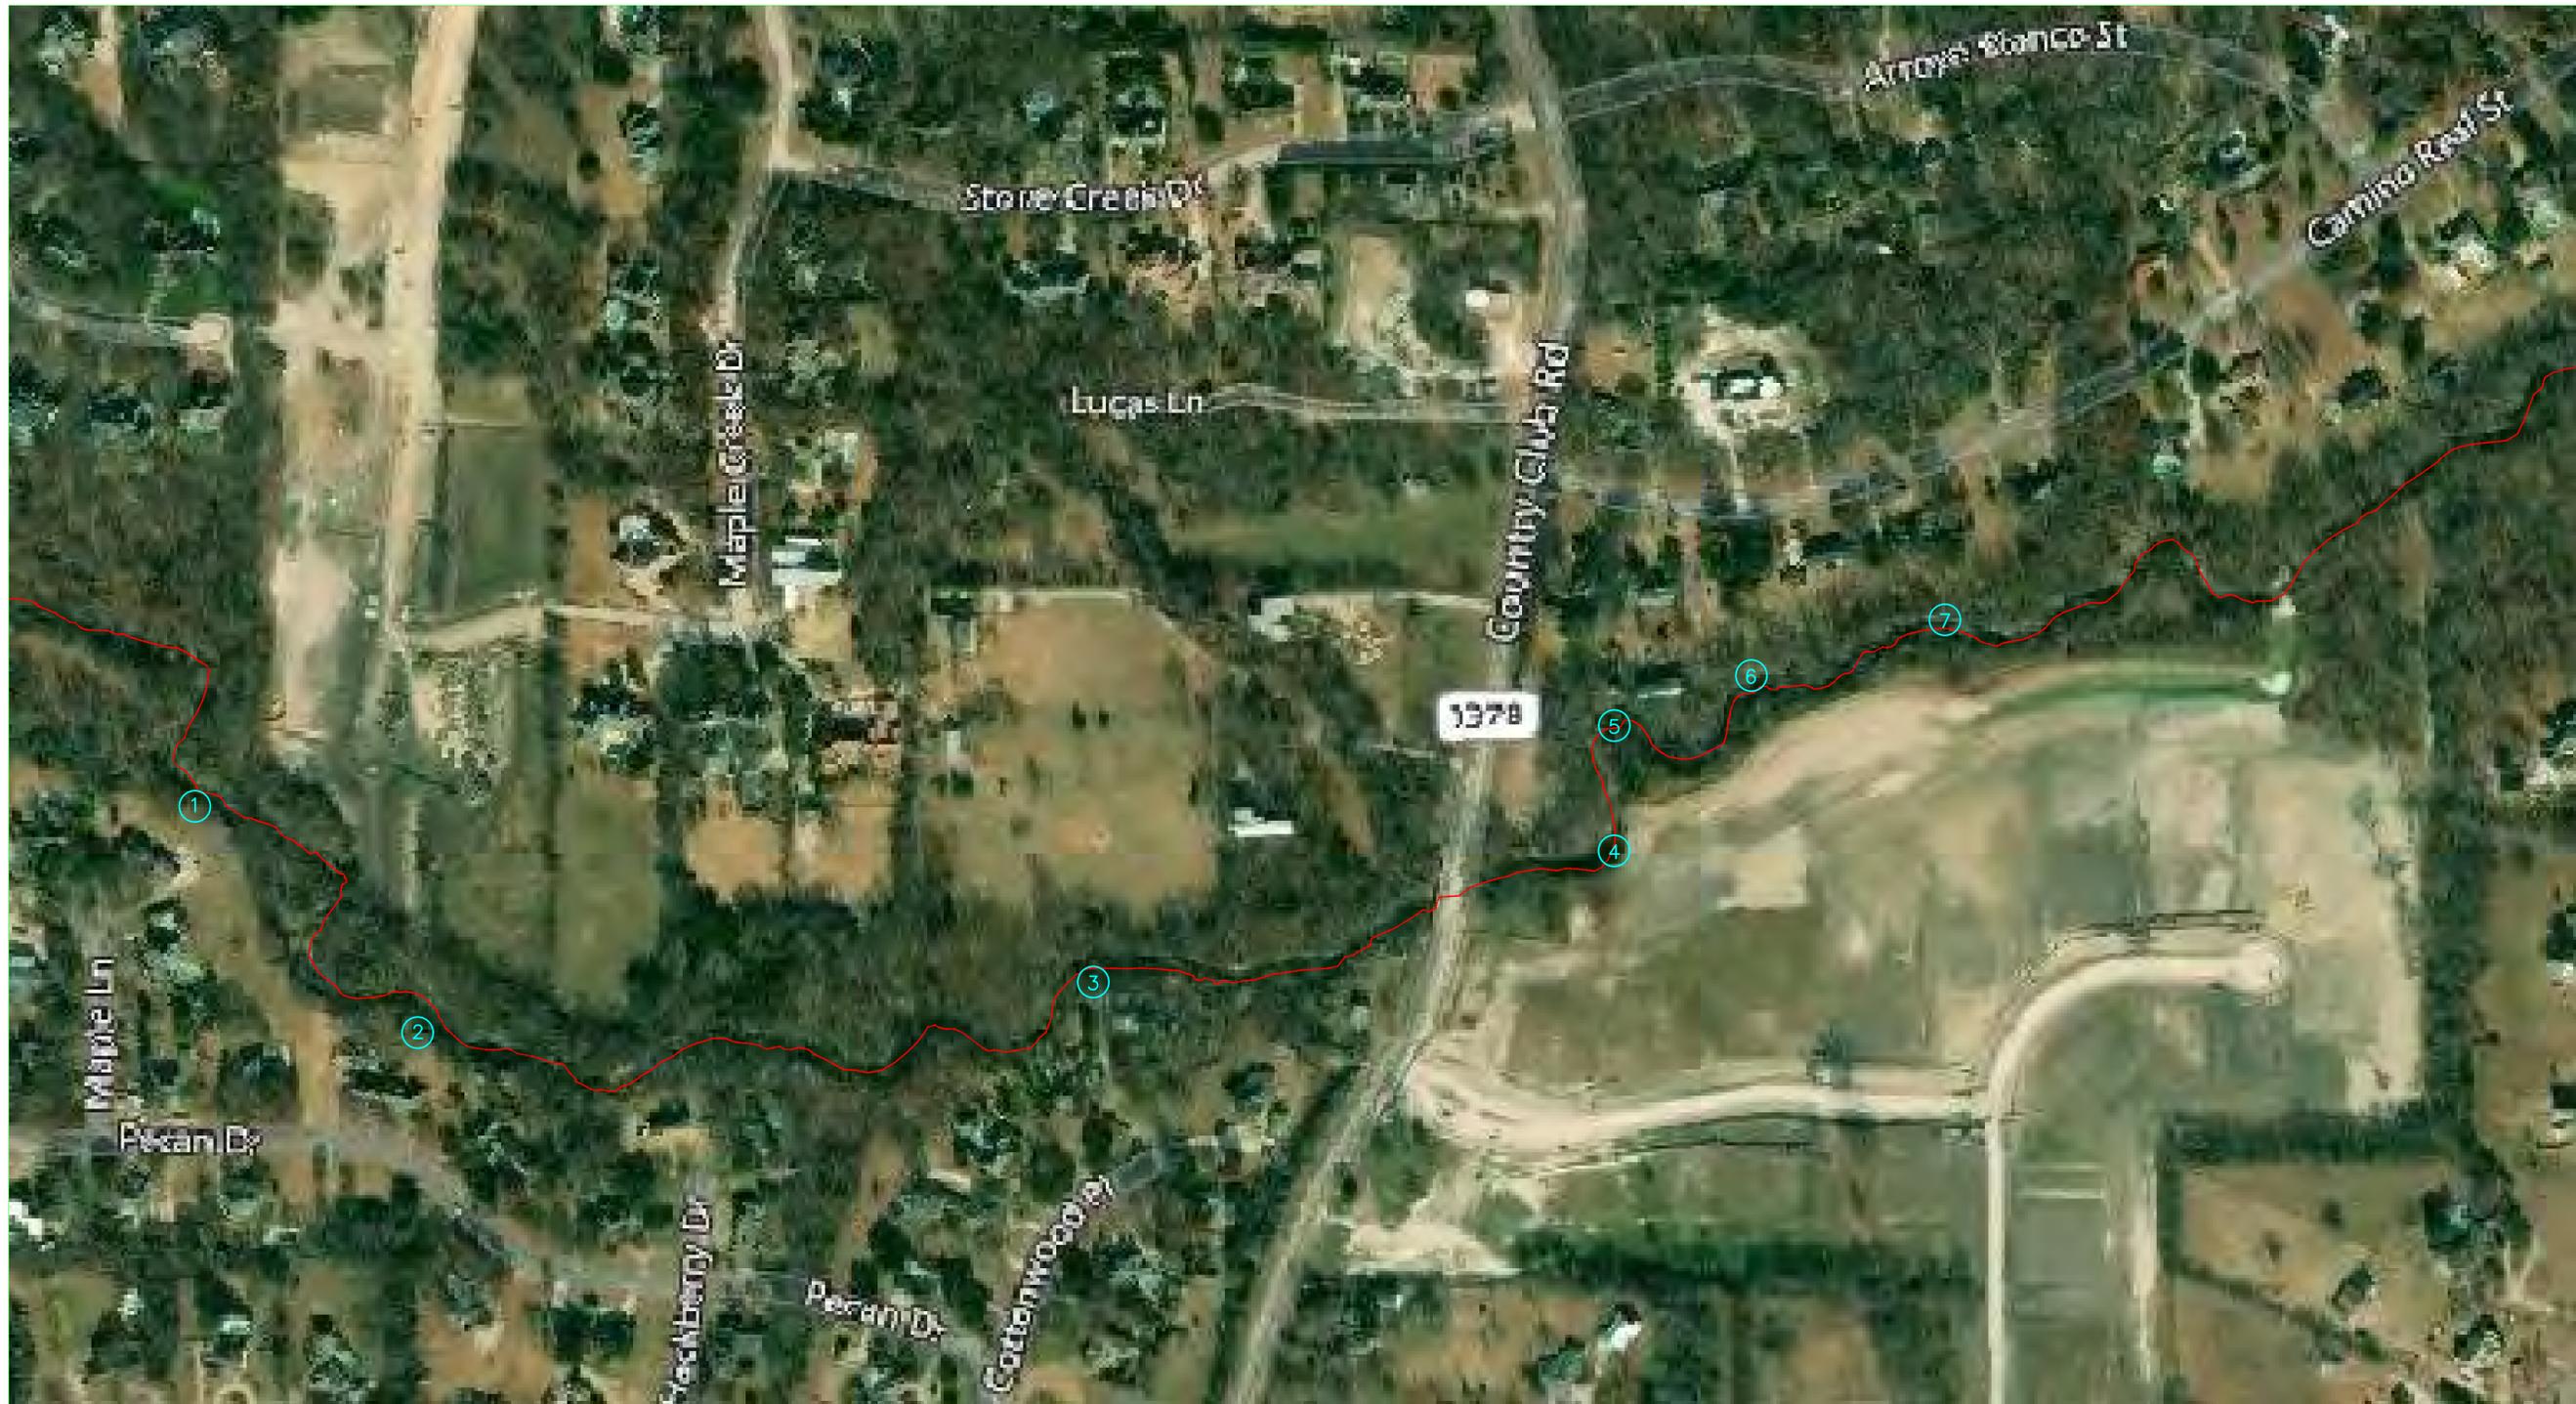
This study included observation of reported erosion sites in Foxglen and a field evaluation of Sloan Creek between Harper Landing and the homes on Camino Real. Huitt-Zollars staff walked along the stream to determine the areas undergoing severe erosion, and to document vegetative cover, bank material, sinuosity, bank slopes, bank height, signs of streambed head cutting, aggradation and degradation around bends, and stream profile. Some parts of the stream could not be evaluated due to access difficulties related to the water level in the stream or heavy vegetation in the banks and overbanks. A total of 7 locations were identified as having undergone severe erosion, three in Foxglen and three east of the Country Club Road bridge. These locations are depicted in the map in the next page. An in depth analysis was performed to understand the erosion at each site and to provide recommendations for potential solutions.

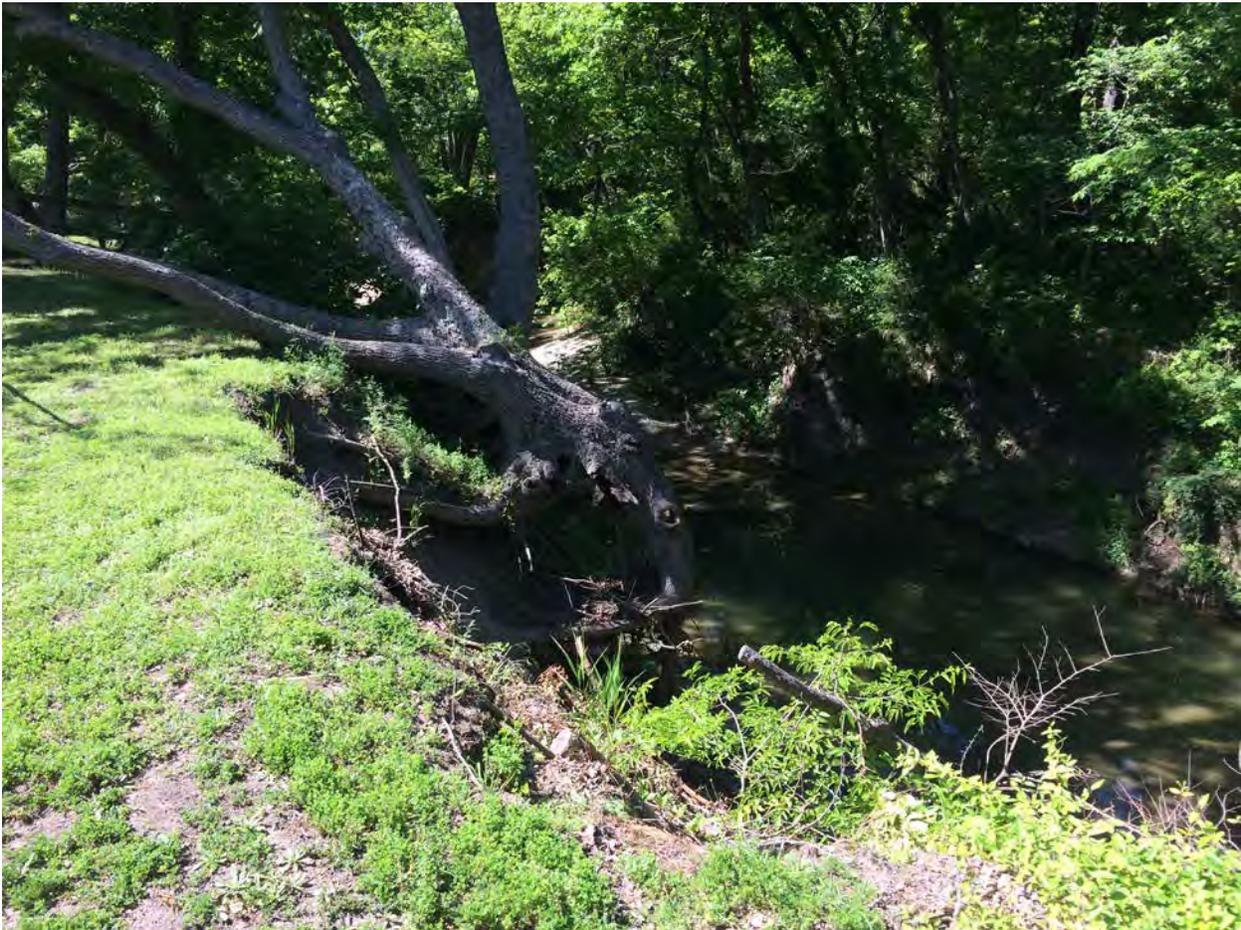
This area is located in the back of the property at 580 Maple Lane, where an unnamed tributary joins Sloan Creek. Erosion was observed in the unnamed tributary as well as the main stream. Bank height is approximately 15 feet. Bank slope is very steep, nearly vertical. Bank material is mostly clay. Natural vegetative cover consisting of brush, grass, bushes, and trees have been partially washed away exposing the bank in some areas, and uprooting large trees. Approximately 20 feet of overbank has been lost due to erosion. The main dwelling in the property is at a safe distance (at least 80 feet) from the eroded bank, but two secondary structures and a light pole guy wire are very close to it. The stream alignment in this area has sharp 90-degree bends causing the flowing water to hit the streambank perpendicularly. As vegetation is lost to erosion the site will become increasingly more susceptible to erosion. The effective hydraulic model for this area indicates the 100-year channel velocities are between 9 and 10 feet-per-second. These are high velocities with a high erosion potential, particularly with the loss of protective vegetation in the streambanks.

Severe bank erosion causing tree uprooting and loss of overbank

Site 1 – This site is located in a section of the stream with high velocities, sharp bends, soft bank material, and has suffered loss of natural vegetative cover. Given the site conditions, geometry, stream alignment and geology, it is unlikely that placing vegetation back in the bank will protect it from future erosion. A hard armoring alternative is the most adequate solution for this site. A hybrid solution combining bioengineering and hard armoring is also an adequate option for this site. Gabions are not recommended along Sloan Creek due to the size and quantity of tree logs and other materials that move through the creek that could damage the baskets. The recommended design is a reinforced concrete wall or concrete block wall up to half of the bank height, transitioning to a geogrid-reinforced slope with turf reinforcement mat used in conjunction with a native grass for the top part. Removal of trees and of one secondary structure, and relocation of the power pole guy wire would be necessary. This wall would be essentially maintenance free after construction. The length of the wall is approximately 220 feet and the construction cost would be approximately \$400,000.

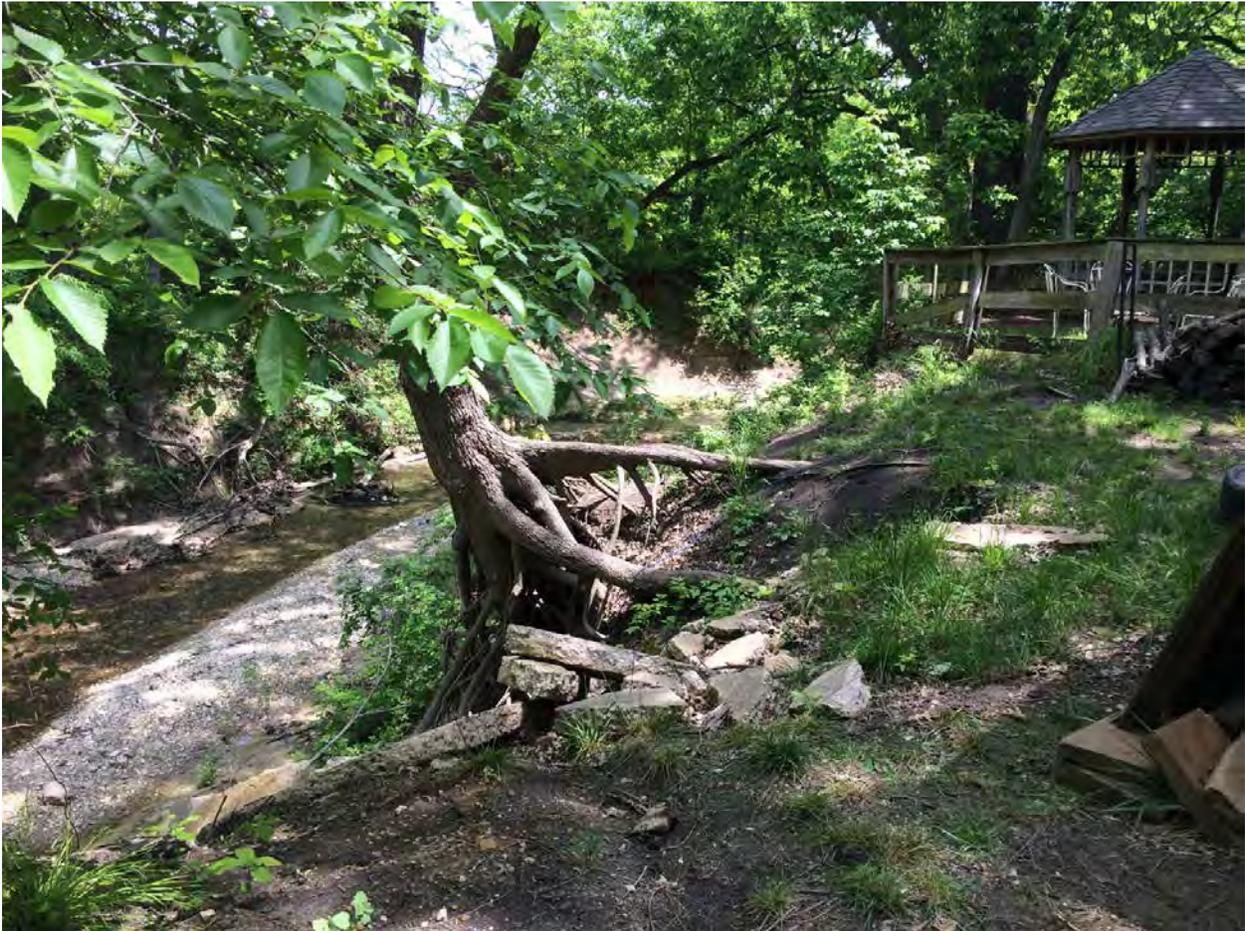
This site is in the back of the property located at 1041 Pecan Drive in the Foxglen neighborhood. Bank is approximately 16 feet in height, partially covered with grass, brush, and trees. Bank slope is approximately 1:1. Large portions of overbank has been lost due to erosion. Large trees have been uprooted and are in imminent danger of being washed away. This section of the channel is very sinuous, with curves and turns, which tend to make the banks more susceptible to erosion. The 100-year channel velocity in this area is between 7.6 and 10 feet per second, which are considered erosive velocities for a natural stream. The main dwelling is approximately 70 feet away from the bank. An existing gazebo sits near the top of bank, facing the potential for being washed away as erosion progresses.

Uprooted tree and gazebo in the background

Site 2 – The conditions at site 2 allow for the construction of an r-rap wall, possibly with geogrid soil-reinforcement, and a gabion foundation. This design would require removal of the gazebo and trees in the bank where the wall will be constructed. The retaining wall would be approximately 180 feet long and 16 feet in height. Construction cost would be between \$300,000 and \$350,000.

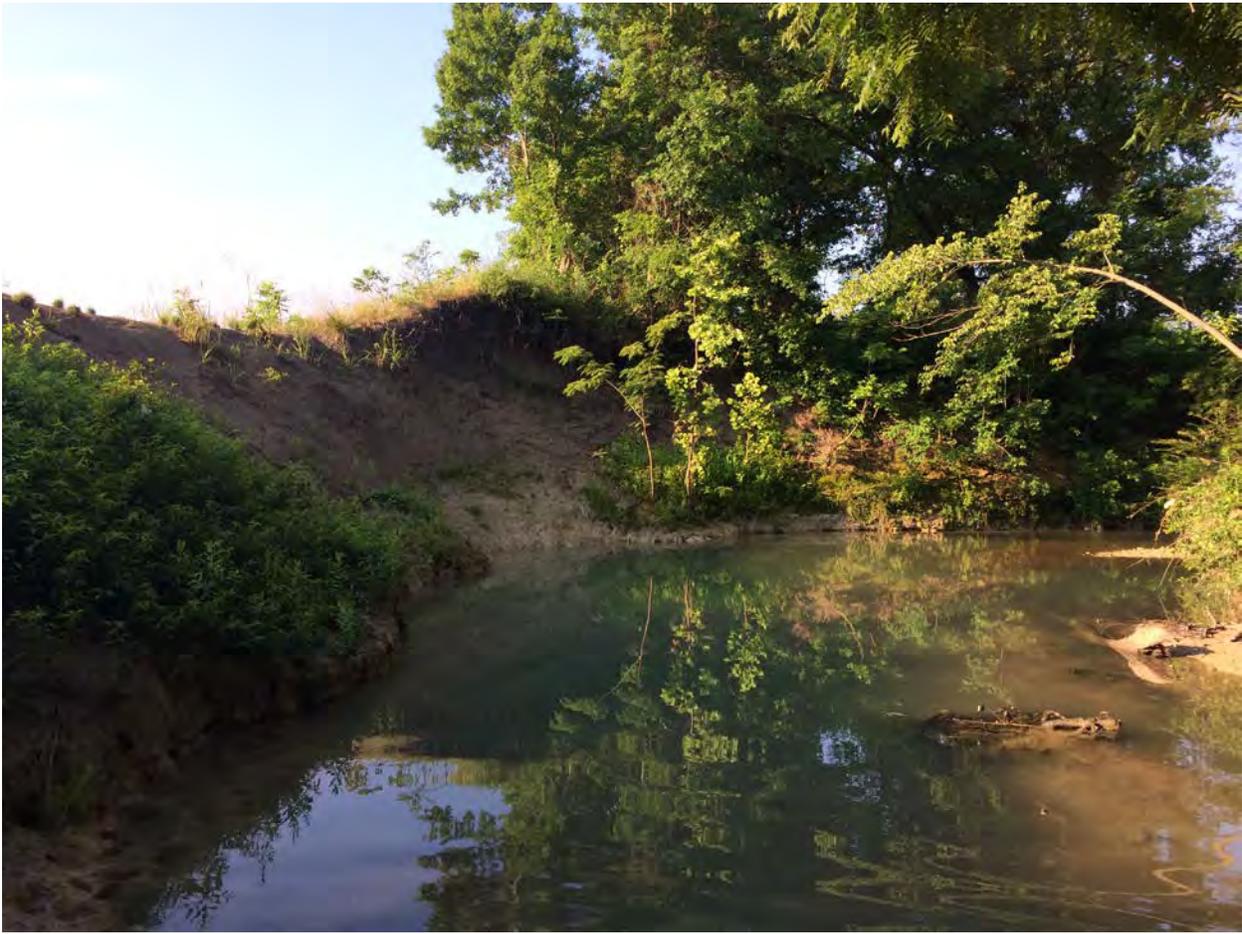
Site 4

This site is located 200 feet east of the Country Club Road bridge. The erosion has taken place around a sharp bend in the stream, which appears to be the area graded to allow the flow from the main creek to enter the overflow channel constructed with the Harper Landing development. Bank material is a sandy clay type, which is not resistant to high forces from flowing water. Currently there are no structures in the property. The HEC-RAS model shows a 100-year channel velocity of 18 feet per second in this area. The main reason for this extremely high velocity is the location just downstream of the bridge, where contraction and expansion coefficients are higher and the flows are constricted through the bridge causing downstream velocities to increase. Erosion is expected to continue along the stream bend.

Erosion along sharp bend on the stream

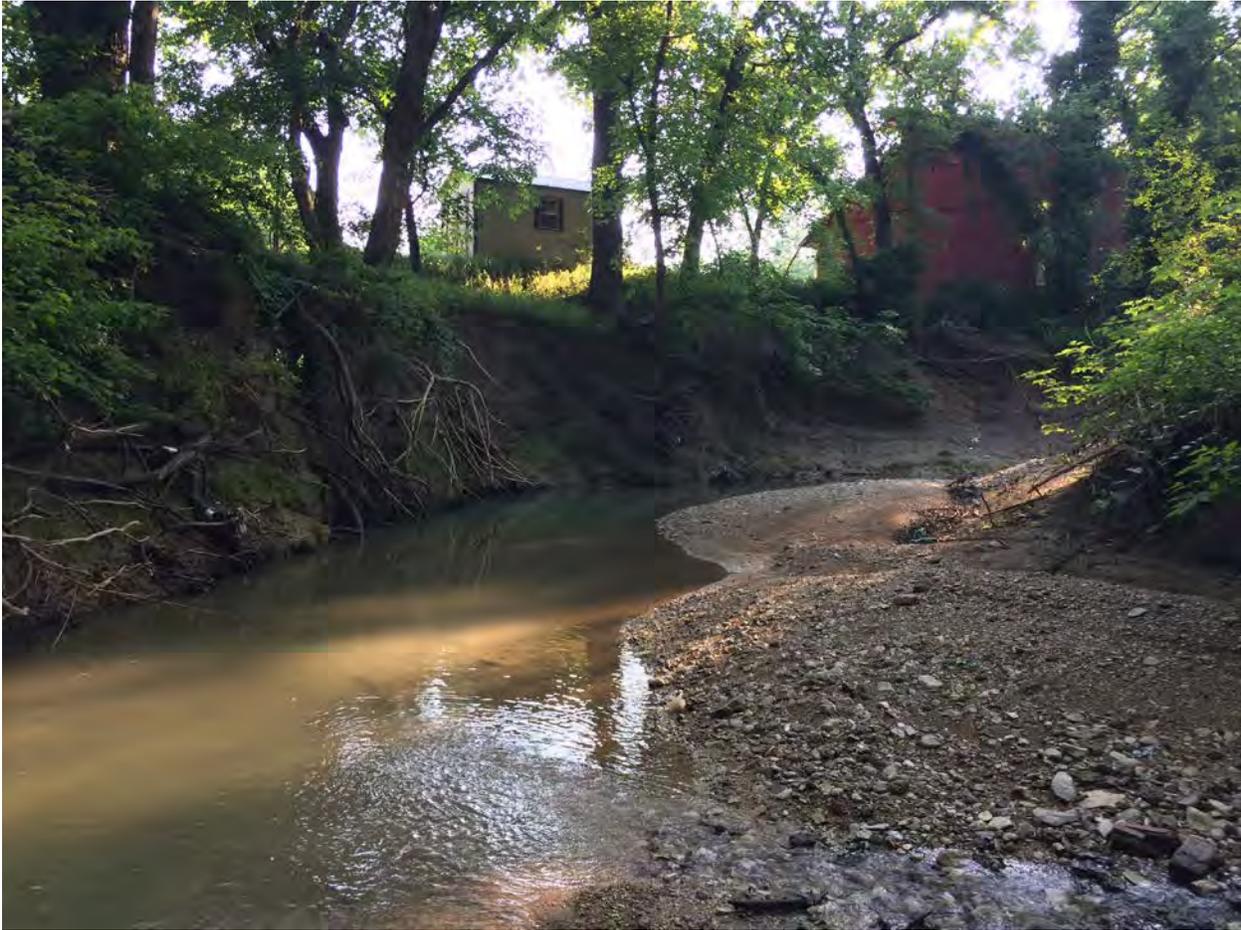
Site 5

This site is located just north of site 4, along another sharp bend in the stream. The bank is approximately 14 feet in height and nearly vertical due to erosion. No vegetation is left in the eroded bank with the exception of overhanging tree roots. Aggradation was observed in the opposite side of the stream, caused by sediment deposition due to lower velocities along the inner bend. A shed is located a few feet from the top of eroded bank. Another secondary wood structure is located a few feet further. The main dwelling is located over 150 feet away from the stream. The 100-year channel velocities in this area transition from 18 to 5 feet per second, around the stream bend. The sharp bend helps to slow the velocity down at the cost of eroding the bank. Erosion is expected to continue along the stream bend, taking additional overbank area, trees, and possibly one of the secondary structures closer to the creek bank.

Bank erosion in the outer bend, and aggradation in the inner bend.

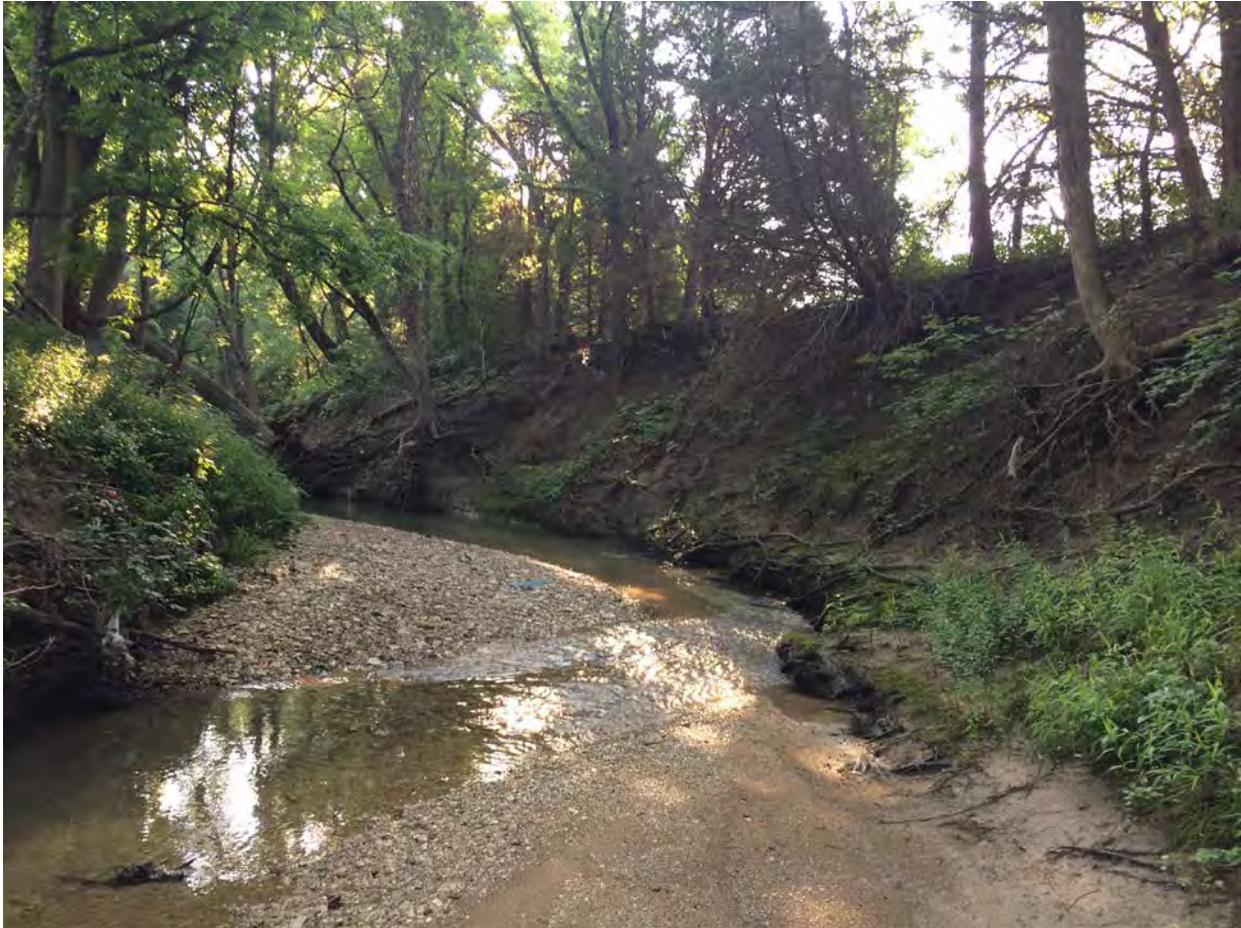
Site 6

This site is located about 200 feet east of site 5. Bank height, material and vegetative cover is similar to site 5, but the banks are not as steep. Aggradation was observed along the inner bend, and degradation along the outer bend. No structures were visible near the stream. The main dwelling is more than 100 feet away from the stream. The average channel velocity is 3 feet per second as shown in the hydraulic model. This is considered a low velocity, not expected to cause streambank erosion. Headcutting was observed in this area suggesting the stream profile has dropped.

Bank erosion in the outer bend, and aggradation in the inner bend.

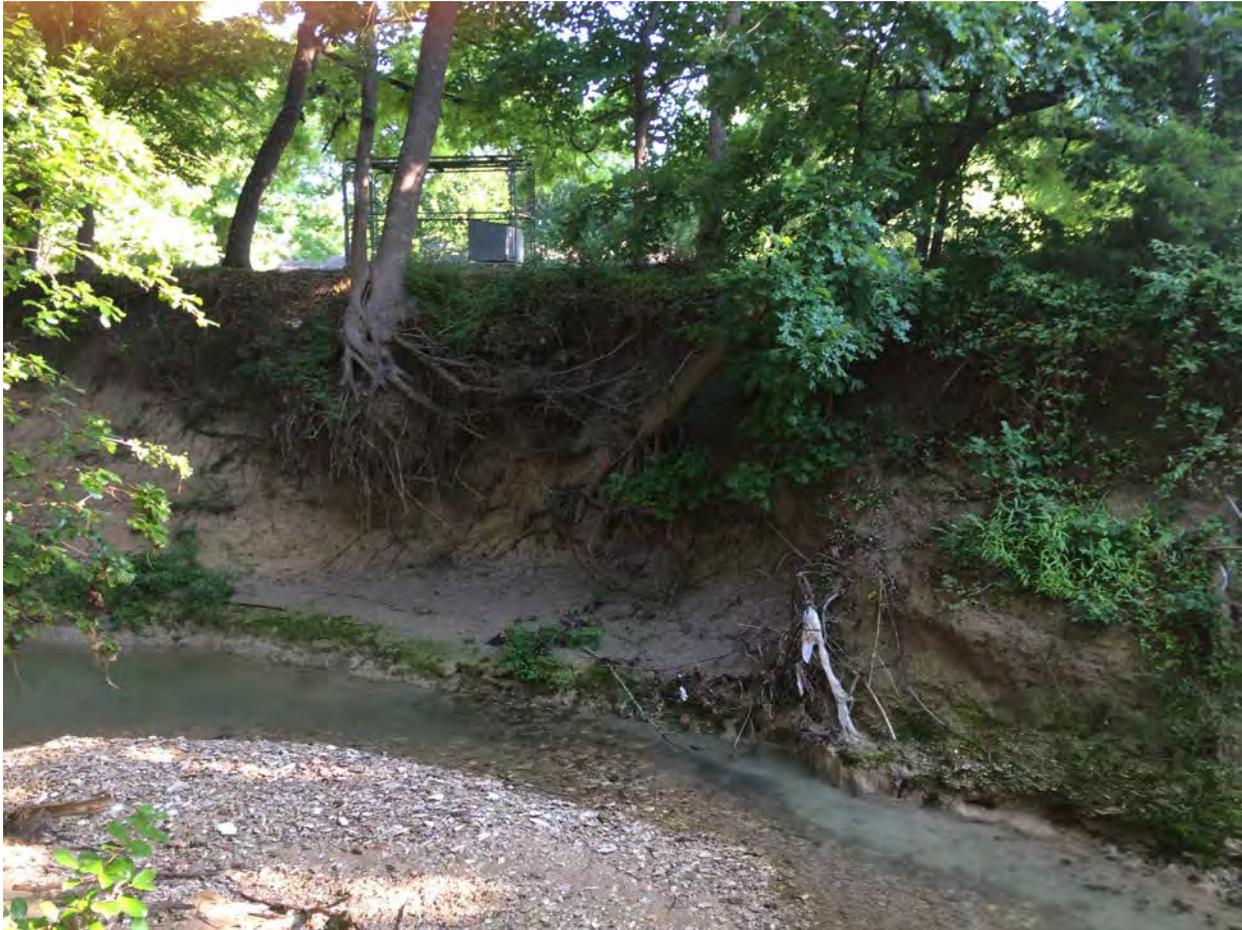
Site 7

This area is located about 300 feet east of site 6. Severe erosion was observed around the inner stream bend, with no vegetative cover left and trees being uprooted. The bank material appears to be the erodible sandy clay. The bank is nearly vertical and about 14 feet in height. Channel velocity in this section of the stream is approximately 9 feet per second, which is considered high and erosive for a natural stream. The main dwelling in the property is about 100 feet away from the eroded streambank.

Severe erosion at stream outer bank
