# DOWNSTREAM ASSESSMENT

MOLODOW AND COLLINWOOD SITES

Town of Fairview

May 2020

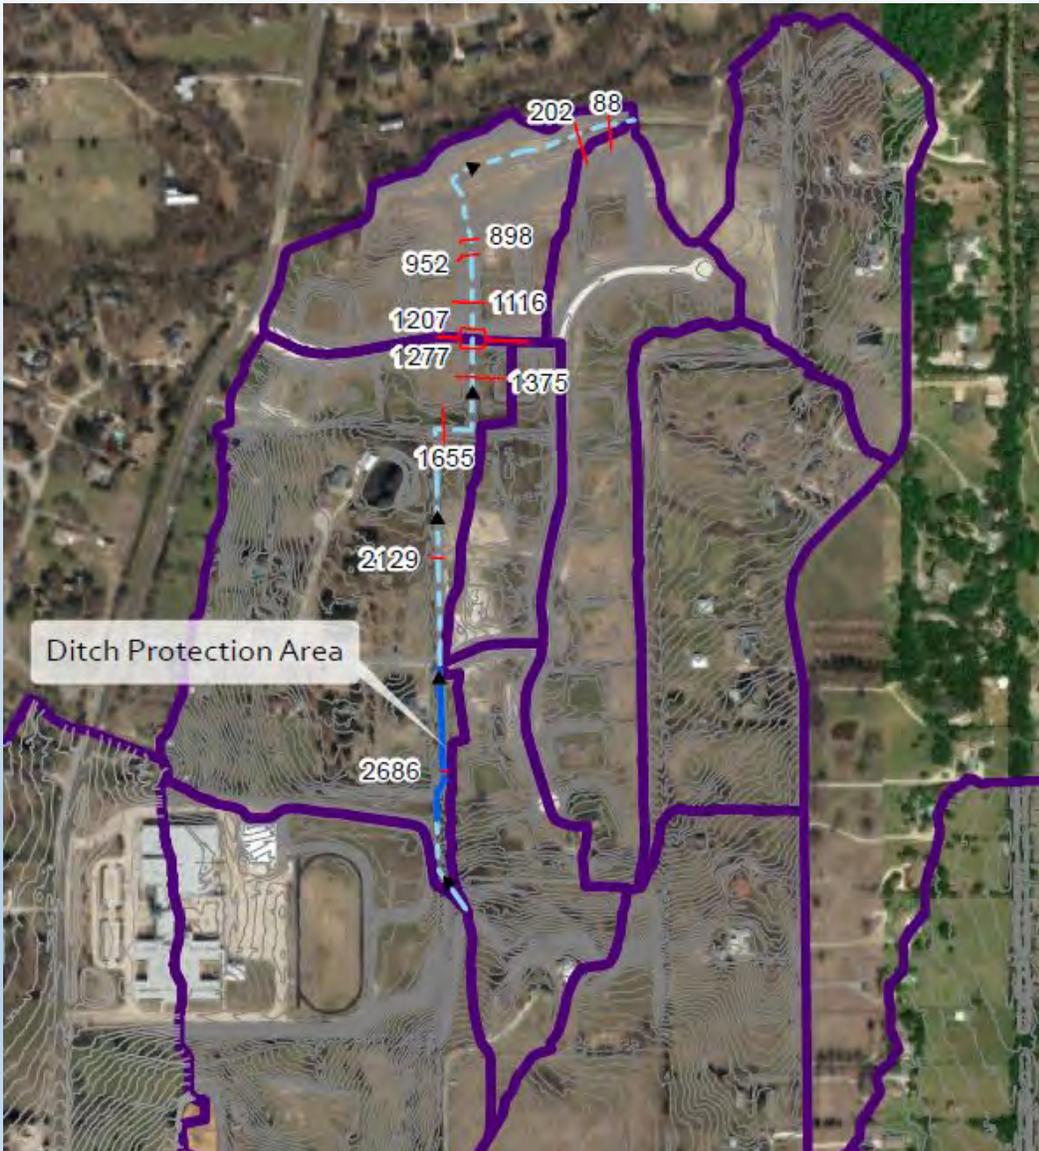
# Hydraulic Analysis

- Increase in Discharge to Existing Ditch Warranted a Hydraulic Analysis to Determine Impacts Downstream
- Results Indicate an Increase in Channel Velocity From 5.4 fps to 6.7 fps. Erosion Expected on Grassed Channel.
- Ditch has adequate Capacity to Convey Developed Flows, But Will Need to Be Protected To Prevent Erosion.
- Ditch Protection Limits Should Be From Site's Northwest Corner to Homestead Drive. Ditch Should Be Extended to Site's Northwest Corner.
- Channel Velocities d/s of Homestead Drive Also Increase, But Are Non-Erosive.

- Flows in The Existing Ditch Will Increase, Causing Higher Channel Velocities. A portion of The Ditch From The Site's Northwest Corner to Homestead Drive Should be Protected to Prevent Erosion.

- Alternatively, In Lieu of Discharging Into Existing Ditch, Site Runoff Could Be Directed to School Pond to Be Detained And Released at A Lower Rate Into Ditch. This Would Require The Existing Pond to Be Expanded to Provide An Additional 1 Acre-Ft of Storage And Potential Modification to The Outfall Structure, But Would Not Require Protection To The Existing Ditch.

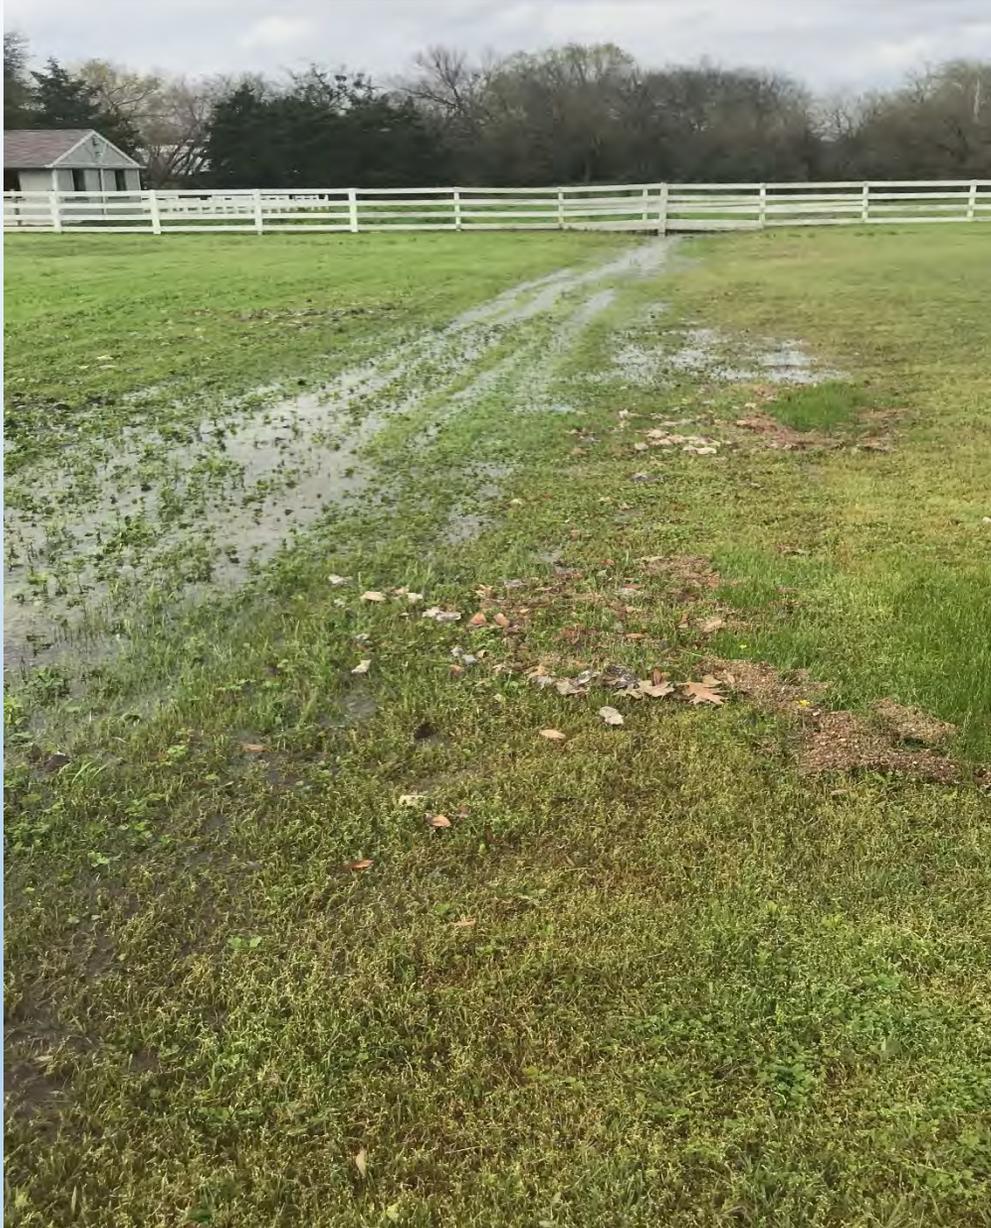
# 480 Home Place – Holly Parsons

- Backyard floods and takes several days to dry
- No way for City to control what residents do within their lots that could adversely impact neighbors
- Would like to receive answers from the City within a reasonable timeframe

- Backyard floods due to large upstream watershed draining through yard. Town may consider regulating streams draining large areas. This would require easements dedicated to the Town.
- Grading a swale though this and downstream properties will alleviate flooding.
- More structured process for receiving and answering resident's concerns within a timeframe.
- Identify need for additional resources.

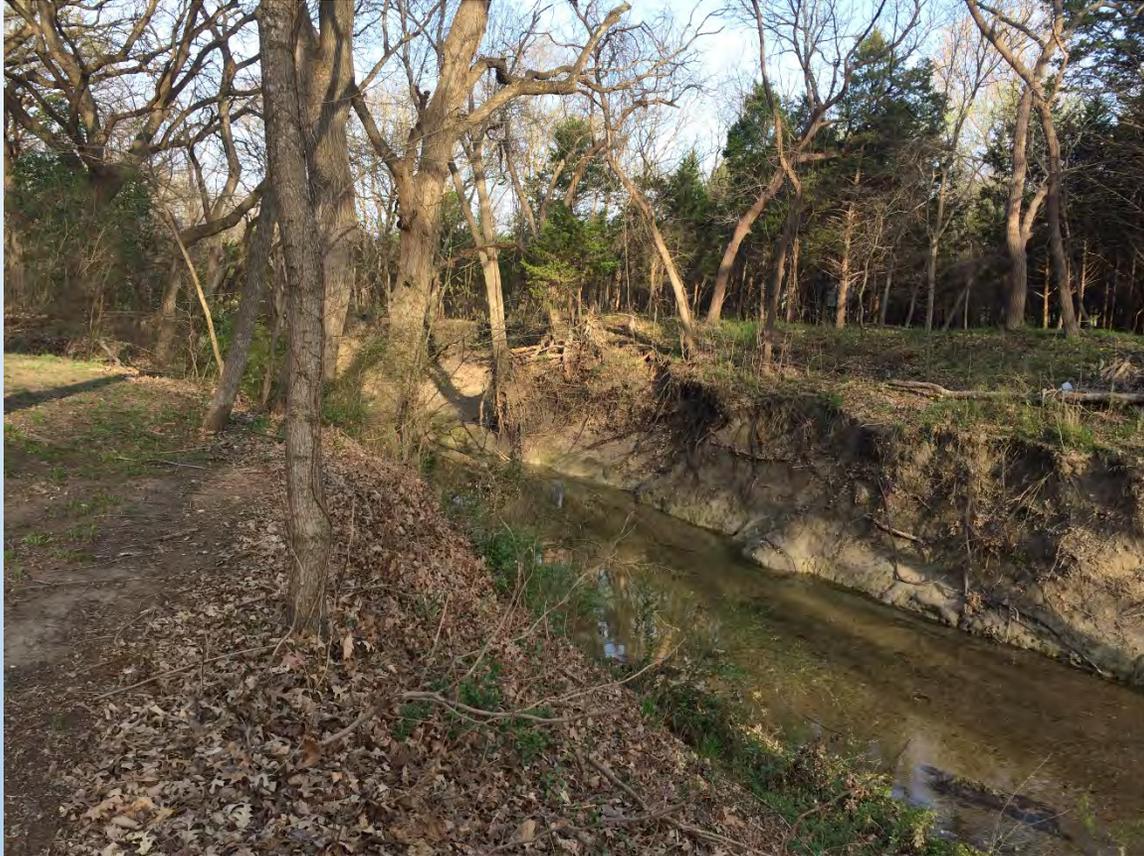
## 540 Hackberry Drive – Cory Zuerker

- Resident understands his property is within floodplain and is expected to flood frequently
- No increase in flooding frequency, except for 2015
- Erosion taking place along Sloan Creek streambanks

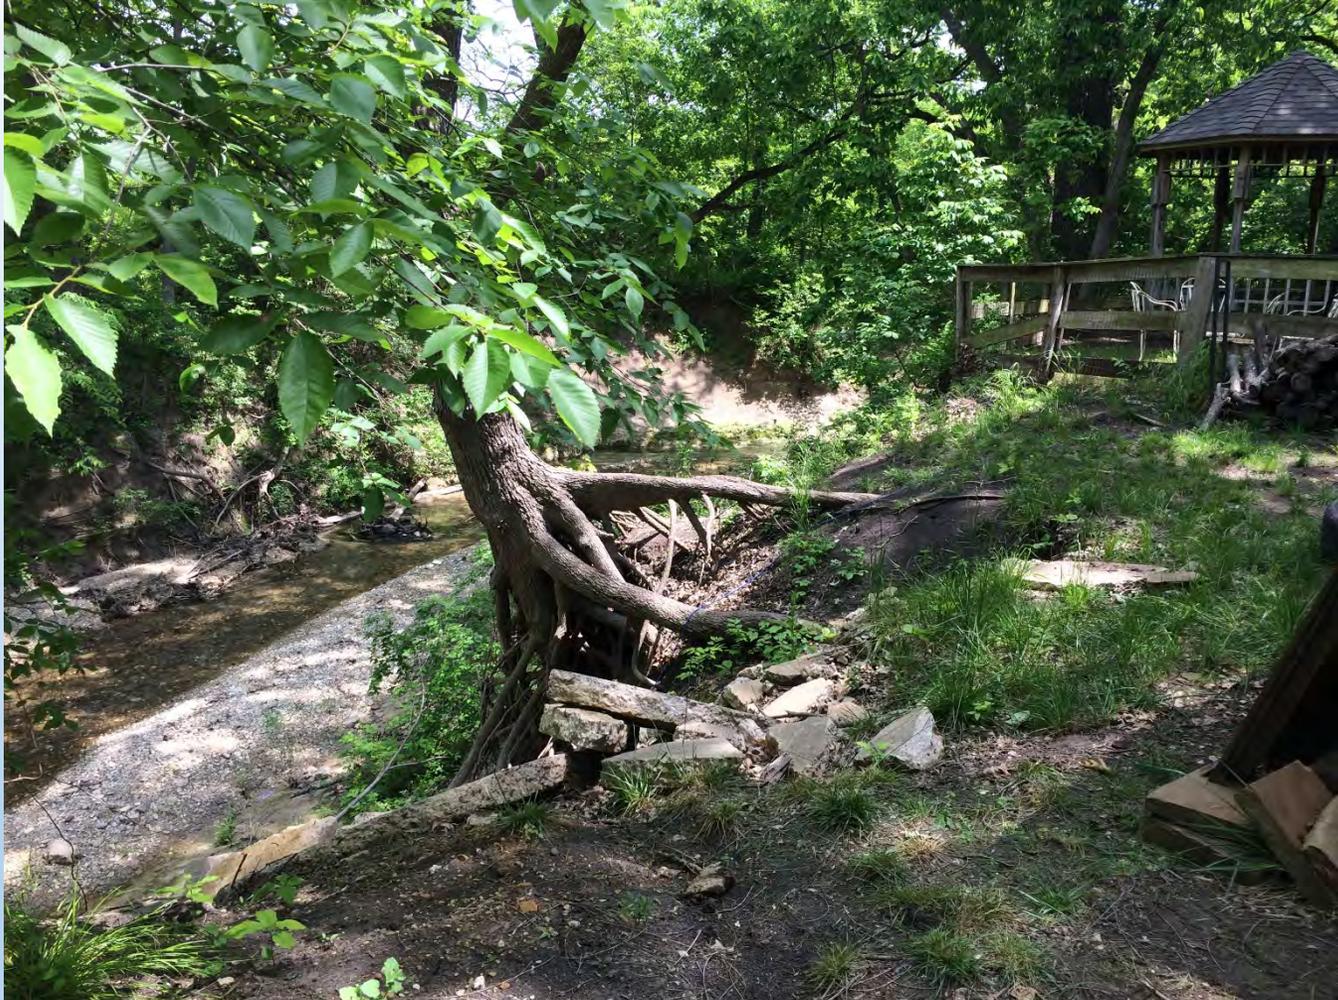
# Rachelle Farkas (and Foxglen neighbors) – 1041 Pecan Drive

- Street floods and takes up to 2 weeks to dry out, allowing for bad smell, mosquito and algae growth.
- Severe streambank erosion caused loss of yard up to 15-ft and large trees in backyard to fall and be carried down Sloan Creek

- Swale between lots providing positive drainage will drain water from street to Sloan Creek
- Streambank protection highly recommended to stop bank erosion.

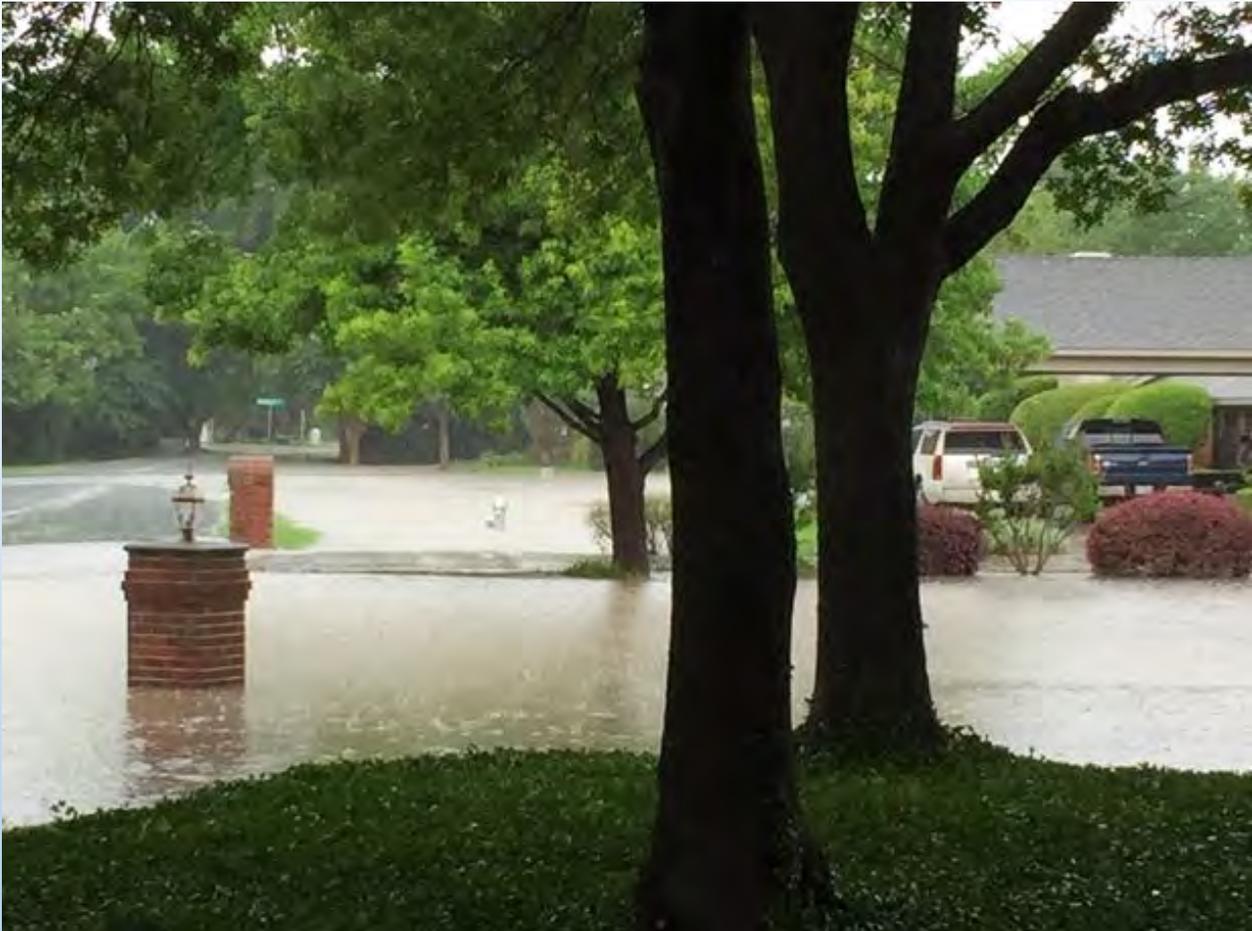
# 1060 Pecan Drive

- Homeowner believes more frequent flooding in his front yard is due to his neighbor's driveway being raised, constricting the natural drainage path.

- Increasing the culvert opening under the recently raised driveway is expected to decrease front yard flooding and restore drainage back to or similar to its original condition.
- Increase in frequency of flooding also due to greater rainfall amounts seen in the past 5 years.

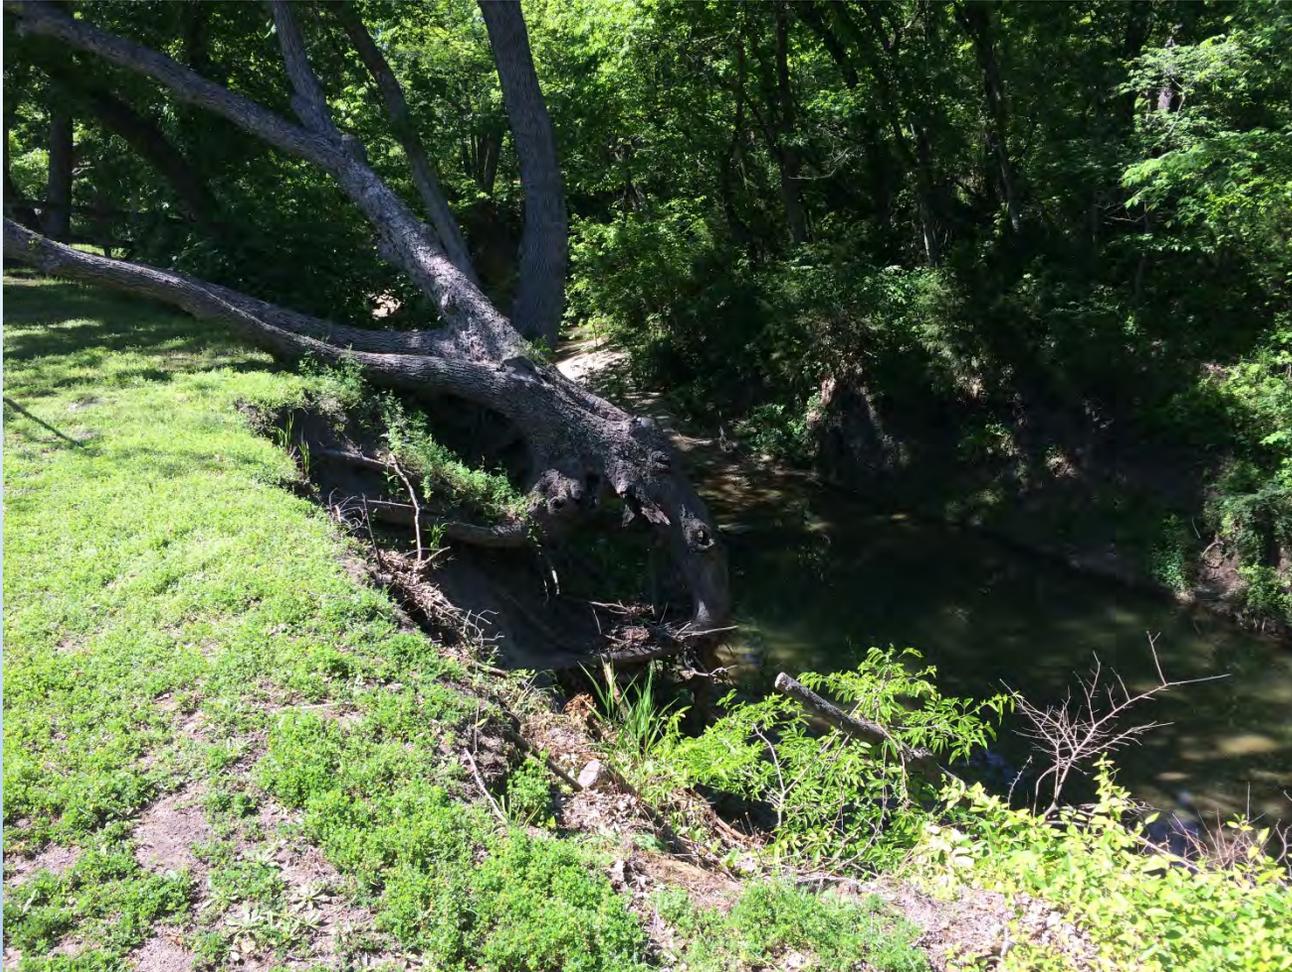
# 580 Maple Lane

- Severe streambank erosion has caused the loss of as much as 20-ft of yard at three different locations.
- Large trees have fallen into the creek due to bank erosion
- Concerned about continuing trend of erosion causing additional loss of yard and large trees.

- Streambank erosion is the most severe out of all the properties observed.
- Immediate streambank protection is highly recommended to prevent further bank erosion, loss of land and trees.
